# Guide to Assessment and Repair of Flood Damaged Timber and Timber Framed Houses

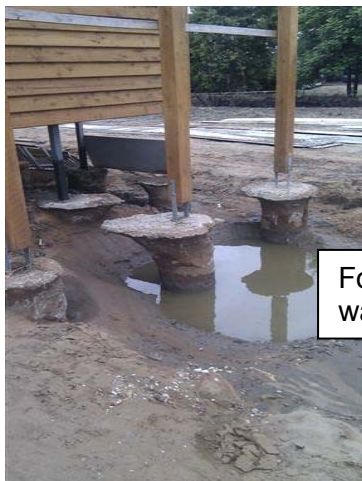
Footings scoured out by fast flowing water

Failure to address or correct these types of faults could severely affect the future structural performance of the building.

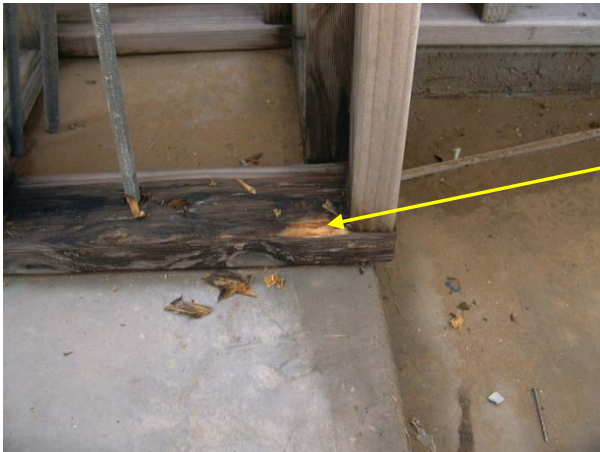
Although heavily discoloured with surface mould and blue stain, the pine timber is still sound as shown by scraping back the surface layer

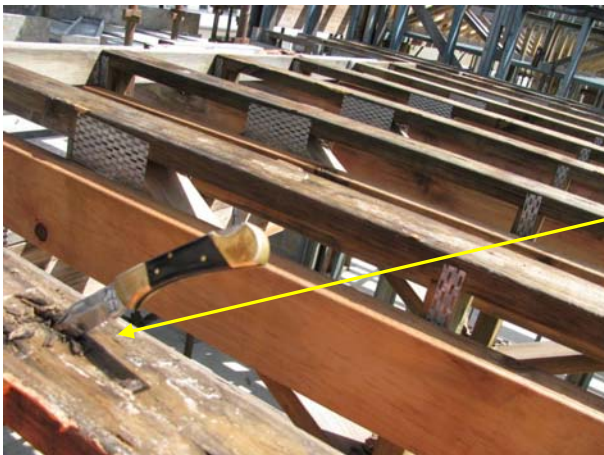
Decayed timber is soft and spongy and can easily be penetrated with a knife or screwdriver

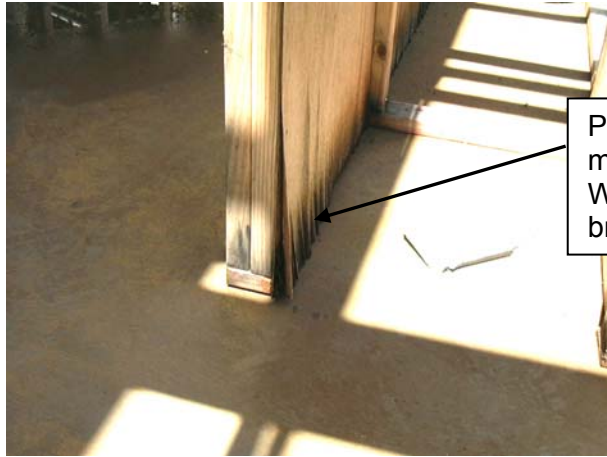
Plywood sheet bracing affected by moisture. Replacement required. Where necessary fix temporary braces.

In houses built after about the mid 1970's, **wall bracing** using wall lining materials (plasterboard, plywood, hardboard and fibre cement etc) as the brace may have been used. Where wall linings are stripped, temporary diagonal timber braces (70x35 pine) at 30° to 60° should be nailed to the top plate, bottom plate and studs to each wall to maintain the houses bracing strength prior to re-instatement of permanent bracing and wall lining.

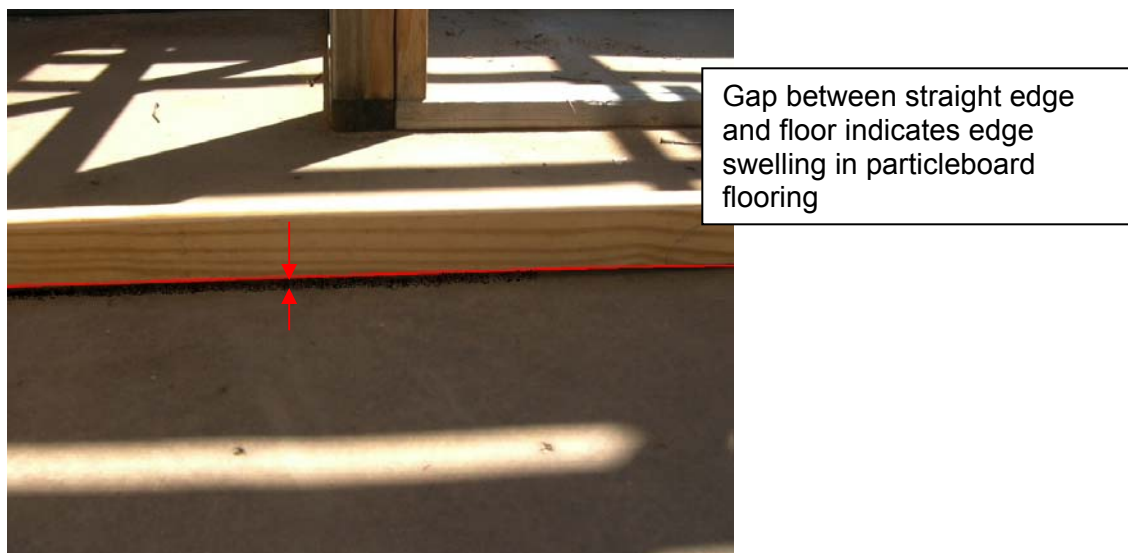
Particleboard flooring is more susceptible to moisture induced swelling than timber or plywood, particularly at sheet edges and depending upon the type of particleboard (some boards are manufactured using moisture resistant glues), may have suffered loss of structural integrity. There will be only minor loss of swelling when the particleboard dries out.

Allow the particleboard flooring a minimum of 4 months to dry out before re-assessing and any rectification that may be required. As a guide only, it is suggested that if sheet edges have swollen more than 5mm (i.e. would need to be sanded back by 5mm or more to get a flat floor) then the structural adequacy of the flooring has been compromised and needs rectification by either replacement or installation of a new structural floor over the existing particleboard.
